Risk Management and Preventive Conservation of Cultural Heritage: the Case of Karaman Hatuniye Madrasa and Karaman City Museum

Gülşen Dişli^{1*} and Rukiye Merve Kilit¹

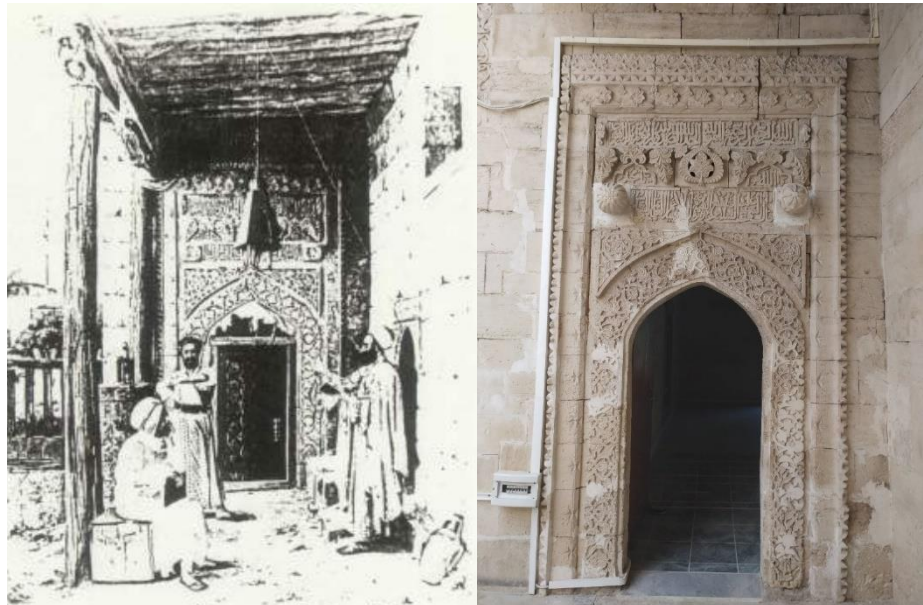
Figure 4. Osman Hamdi Bey's painting "Hodjas speaking in front of the mosque" (left) (Demirsar 1987, p. 241) and the current state of the door to the winter classroom to the right of the main iwan (right).

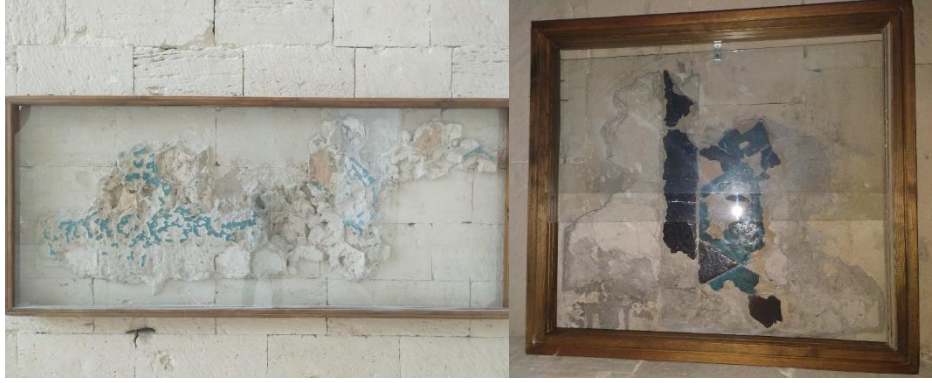
Figure 5. Tile ruins of Karaman Hatuniye Madrasa.

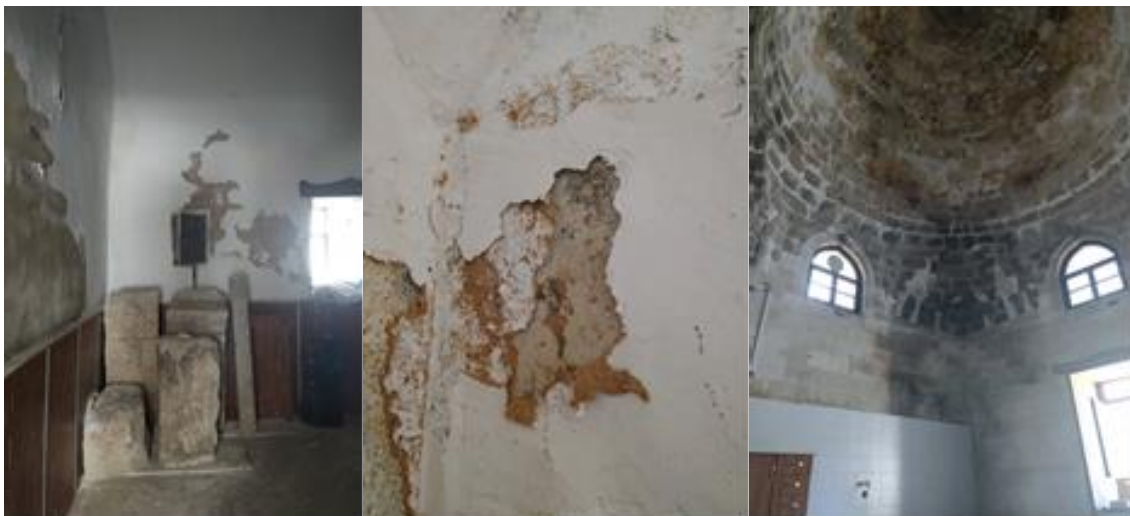
Figure 6. Material deterioration in different parts of Karaman Hatuniye Madrasa.
